**[Docket No. FAA-2024-0769; Project Identifier AD-2023-00556-T; Amendment 39-22815; AD 2024-16-09]**

### **Airworthiness Directives; The Boeing Company Airplanes**

**2024-16-09 The Boeing Company:** Amendment 39-22815; Docket No. FAA-2024-0769; Project Identifier AD-2023-00556-T.

Air Transport Association (ATA) of America Code 53, Fuselage.

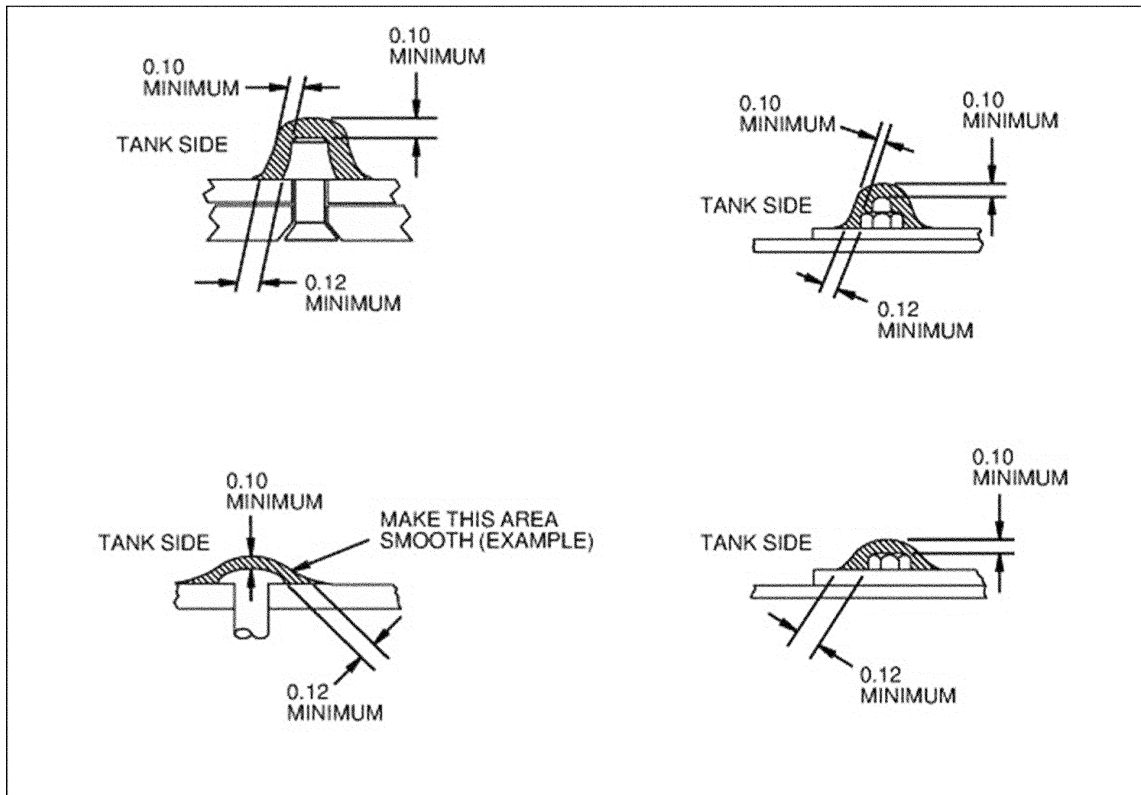
**Figure 1 to Paragraph (h)(3)—Cap Sealing Dimensions (all Dimensions are in Inches)**

Boeing concluded that only the cap seals on the interior side of the fuel tank require the dimensions specified in Figure 1 of paragraph (h)(3) of the proposed AD to perform their intended function, which is consistent with the labels shown in Figure 1 of paragraph (h)(3) of the proposed AD. Boeing recommended replacing the text “applying a cap seal (sealant) to a fastener, fastener head, and fastener threads and collars, for this AD, during application of any cap seal to a fastener, fastener head, or fastener threads and collars” with the text “applying a cap seal (sealant) to a fastener location that penetrates the fuel tank boundary, for this AD, during application of any cap seal to a fastener, fastener head, or fastener threads and collars inside the fuel tank.”

(3) Where any service information referenced in Boeing Alert Requirements Bulletin 777-53A0100 RB, dated March 16, 2023, specifies applying a cap seal (sealant) to a fastener, fastener head, and fastener threads and collars inside the fuel tank, for this AD, during application of any cap seal to a fastener, fastener head, or fastener threads and collars inside the fuel tank, the cap seal must be applied using a cap sealing procedure with thickness greater than or equal to the dimensions given in Figure 1 to paragraph (h)(3) of this AD.

The FAA agrees. Boeing 777 AMM 28-11-00 meets the sealant requirements of Figure 1 to paragraph (h)(3) of this AD. As such, it would be an acceptable procedure to follow when sealing inside the fuel tank in accordance with paragraph (h)(3) of this AD. The FAA has added a note to paragraph (h)(3) of this AD accordingly.

**Note 4 to paragraph (h)(3):** Guidance on an acceptable cap sealing procedure for accomplishing the actions required by paragraph (h)(3) of this AD can be found in Boeing Model 777 Aircraft Maintenance Manual (AMM) section 28-11-00.

applied using a cap sealing procedure with thickness greater than or equal to the dimensions given in Figure 1 to paragraph (h)(3) of this AD.
